# Comparison of Current Magnitude Error with and without Temperature Compensation from -40 °C to +125 °C 25 micro-Ohm Shunt & Copper Busbar

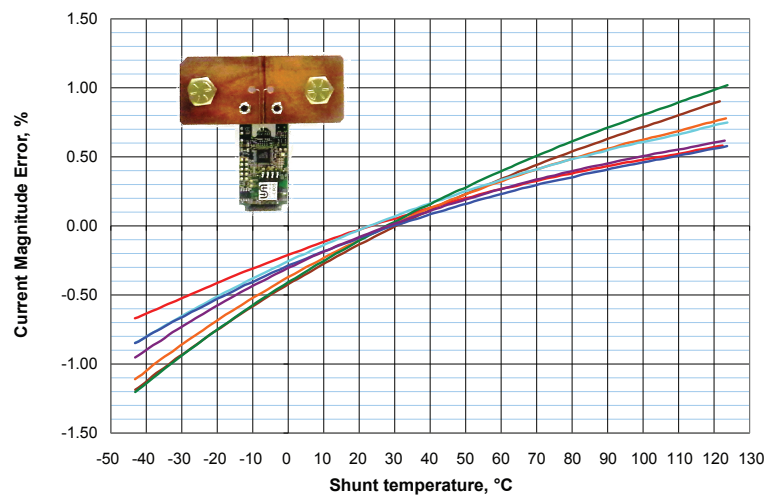
**Current Magnitude Error vs Temperature**

(SFP101 WITHOUT Temperature Compensation, 25  $\mu\Omega$  Shunt )

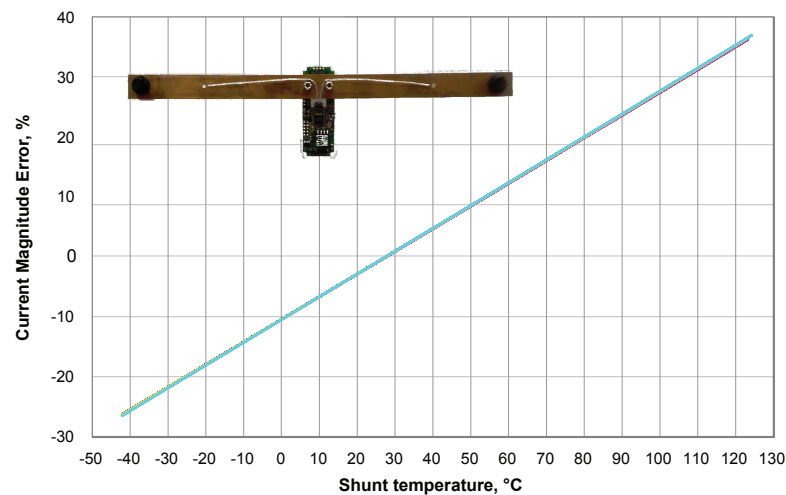
**Current Magnitude Error vs Temperature**

(SFP101 WITHOUT Temperature Compensation, Copper Busbar, 60.5 mm<sup>2</sup>, 50  $\mu\Omega$  )

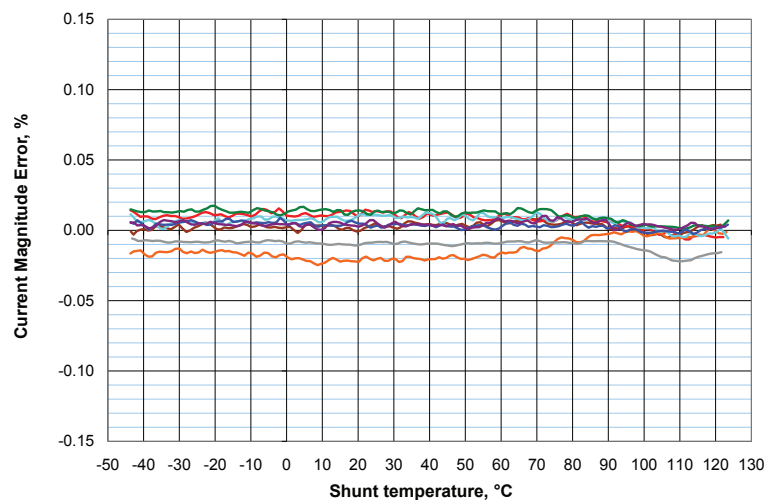
**Current Magnitude Error vs Temperature**

(SFP101 WITH Temperature Compensation, 25  $\mu\Omega$  Shunt, Magnified 10X)

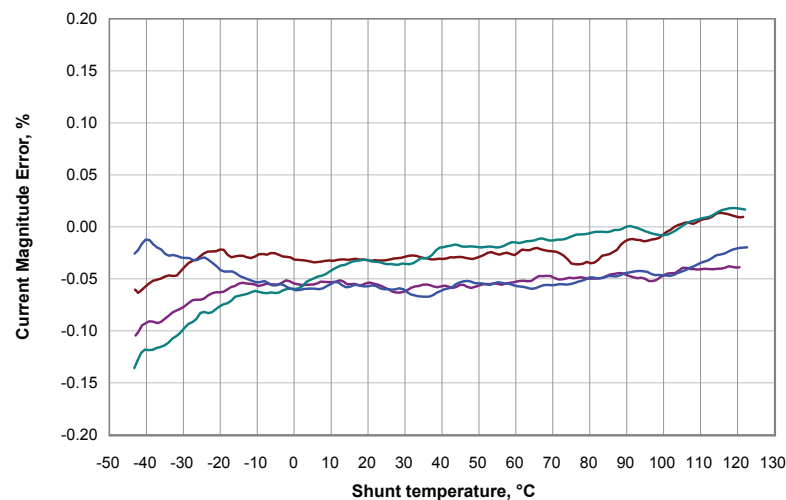
**Current Magnitude Error vs Temperature**

(SFP101 WITH Temperature Compensation, Copper Busbar, 60.5 mm<sup>2</sup>, 50  $\mu\Omega$ , Magnified 200X)
